THE CATHEDRAL ARCHITECT'S REPORT 2011

Salisbury Cathedral Chapter House:

Its Proposed Conservation and Repair

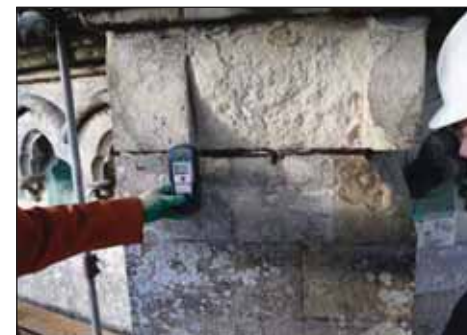
Corroding cramps causing damage to buttress masonry

The 19th century extension of the buttresses has resulted in a patchwork of jointing, with a profusion of concealed ferrous cramps on all three faces. Many are corroding (they are not encased in lead) and bursting the surface of surrounding masonry. It is proposed to take out all ironwork above the second scaffold, those below being relatively accessible for future replacement as the need arises.

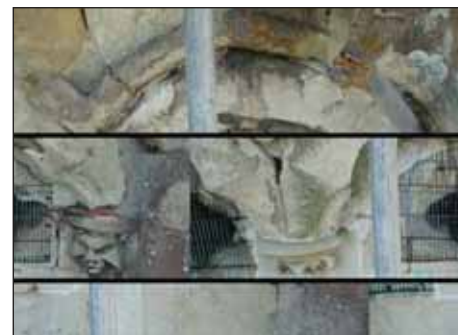
The masonry is generally cleaner and subject to less decay than has been found on the cathedral itself. The thin-walled parapet is built using through stones, the design varying from that of the main body of the cathedral with a simplified and more robust moulding detail. Evidence of mis-alignment appears in each bay but is not structural, being attributed to workmanship during setting out of the original construction. This has also resulted in wide joints, in-filled with terracotta tile slips predominantly located between springing stones.

Setting out resulting in mis-alignment

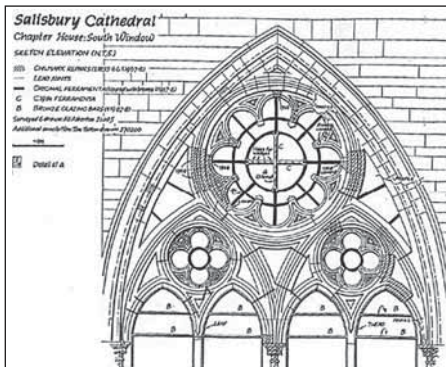
As a result of earlier campaigns, the glazing to the four southernmost bays is in varying condition. Timber frames remained in the lancets of the south-west window only. These were re-introduced in the south facing window in 2005, following the original medieval intention.

The south window recorded in 2005, showing original ferramenta and later repairs.

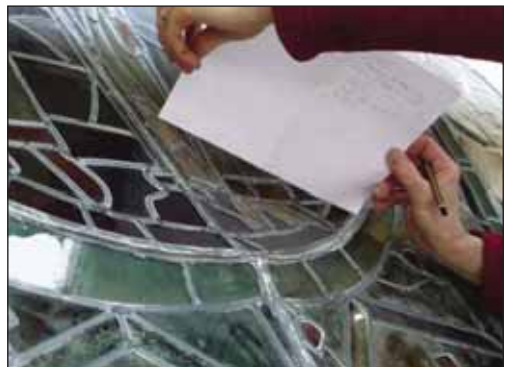
The rest of the windows are presently glazed directly into masonry rebates, the joint being covered by a thick mortar fillet, almost universally cracked and off key. Glazing in the south-east window has bowed since re-leading in the 1970s, being insufficiently tied to the internal ferramenta and is a priority for re-leading.

Bowing to octofoil in south-east window
